# JakMatGeocell

The ground stabilisation mat for  
high pressure animal traffic areas

## CASE STUDY – ALBERT POWWELS DAIRY RACE 02-03-2010

Dairy race stabilisation with **JakMatGeocell**

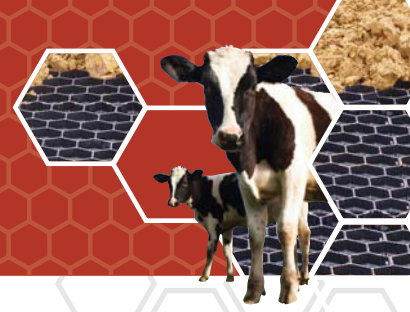
2. The 90 square metres of **JakMatGeocell** was laid by Albert's family and farm employees.

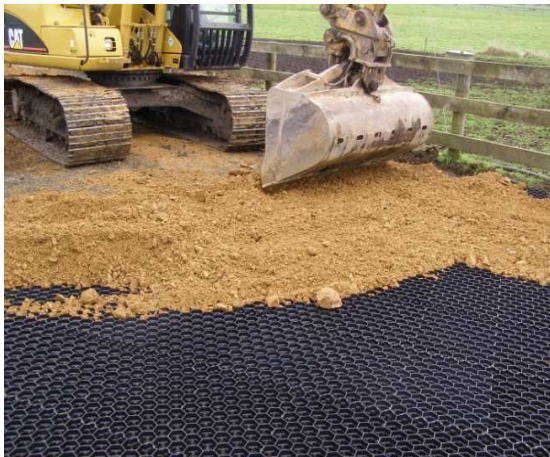
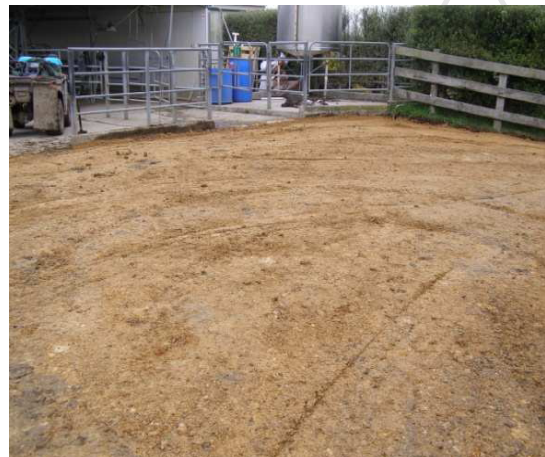
3. The final stages were the filling of the **JakMatGeocell** with a locally sourced Huntly "Crushed Brown Rock" and then rolling. This particular aggregate was chosen for its soft, crumbling characteristics which allowed it to compact tightly into the cells of the mat as well as be sympathetic to the cow's hooves. This layer was to approximately 20-40mm above the top of the mat on completion.

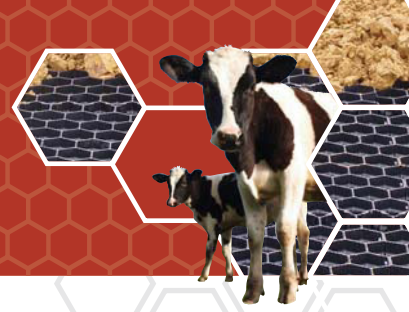
The **JakMatGeocell** has now been down on Albert's race for 7 months and the following the observations were made by him.

- There is a very high wear area just as the cows walk out of the cow shed, after milking, which has now worn down to the top of the JakMat. Albert said. 'I am very interested to see how this area wears in the longer term because it is the long term benefits of the matting that will be the determiner of the overall success and cost effectiveness of the product but at this stage it is standing up very well".
